Raising the

COSTA CONCORDIA

A Crowley Maritime Corporation Publication

The largest maritime wreck removal project in history begins.

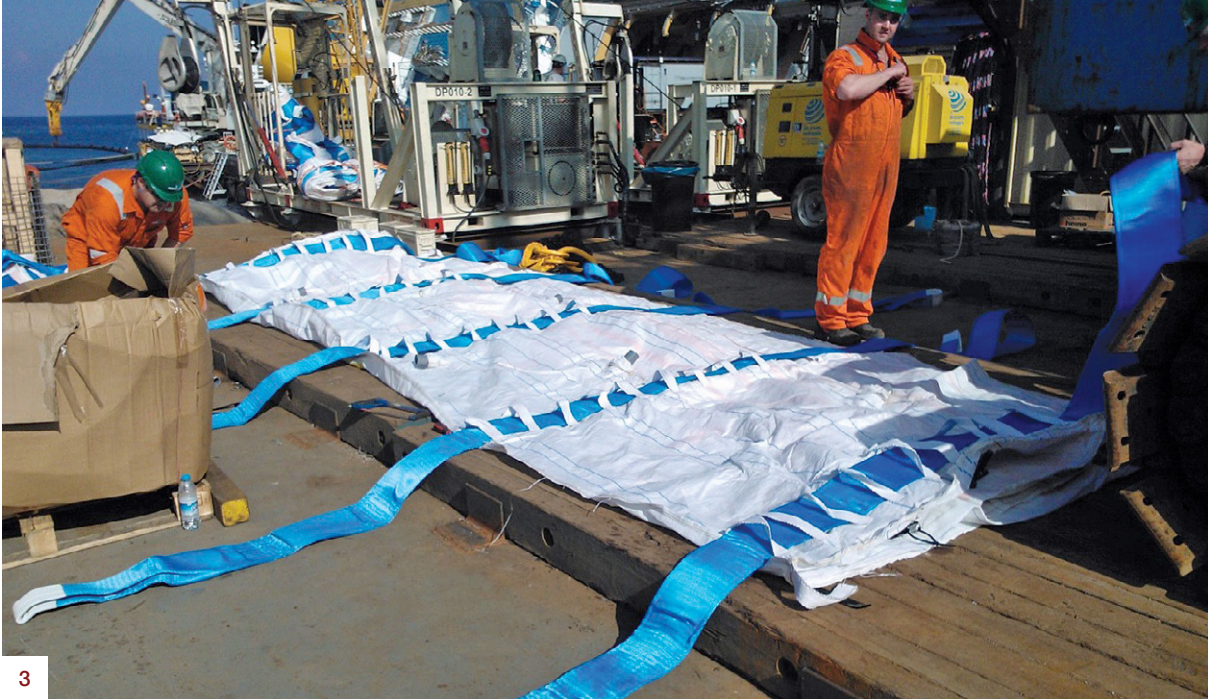
1. A rendering illustrating the platforms or “false bottom”
2. TITAN’s divers logged around 100 dives per day, amounting to more than 22,000 total dives by the end of the project – the largest dive operation ever in history.
3. TITAN’s dive team hand placed hundreds of eco-friendly, cement-filled grout bags – each the size of a residential swimming pool – between the two spurs of rock under the ship.

Because the ship was suspended at the bow and stern by the two underwater ridges, the center of the ship had to be supported by a platform, or a “false bottom,” to allow the ship to rest upright on the steeply sloping bottom. To create this stable foundation in an uneven terrain, TITAN/Micoperi’s dive team hand-placed hundreds of eco-friendly, cement-filled grout bags – nearly 15,000 cubic meters worth – between the two spurs of rock under the ship. The bags, each the size of a residential swimming pool, were designed with straps for easy removal at the end of the project.

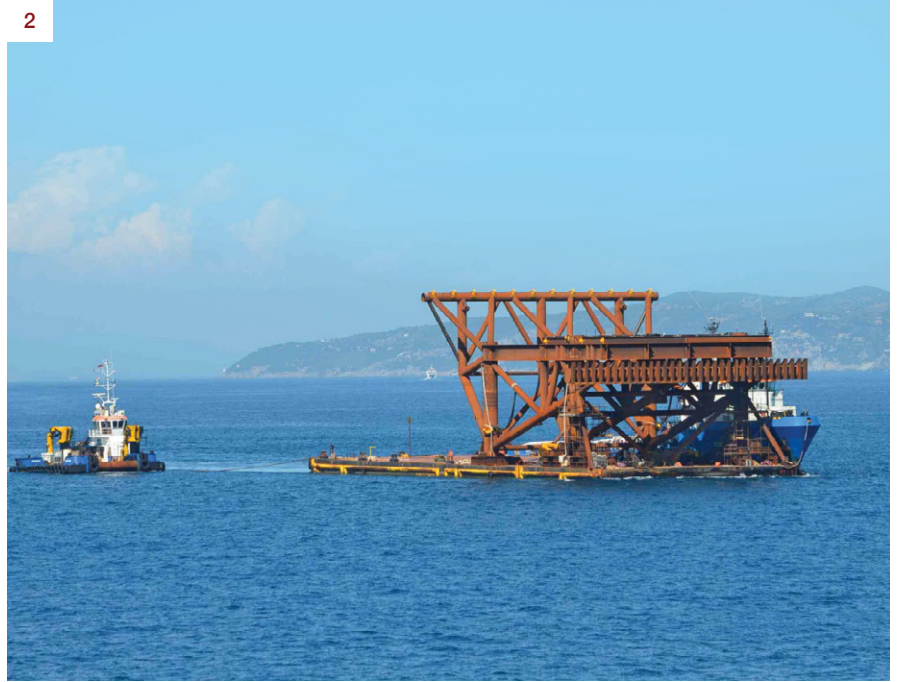
1. Sponsons under construction at Fincantieri Shipyard in Genova
2. Platform 2 is towed out for installation. This platform, which was built at the Rosetti shipyard in Marina di Ravenna, weighed about 1,000 tons and measured 40 meters wide by 22 meters high. It was secured to the granite seabed about 10 meters deep.
3. Strand jacks are hydraulic jacks used to tension the cables and give the wreck more stability. This salvage project used more strand jacks than any other in history.

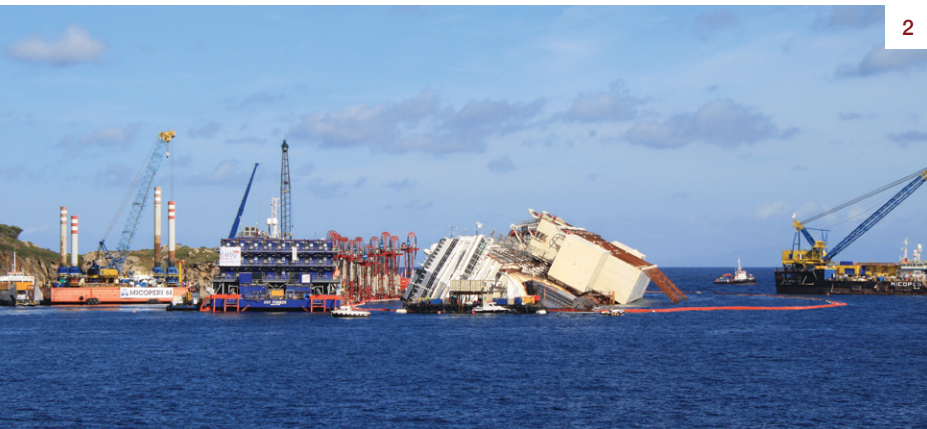
2. The day before the parbuckling, the salvors “pre-tensioned” the wreck, a process involving an initial exertion of force to let it “soak through” the steel and prepare it for the event.

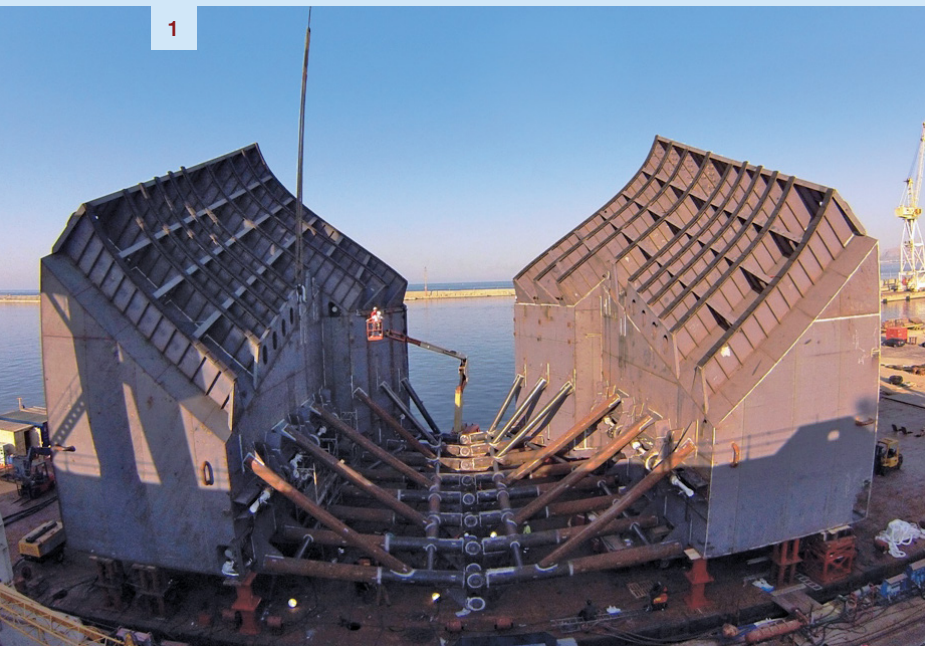
1

1. The “blister sisters” in production in Palermo, Italy.
2. Commonly working in groups under computer control, strand jacks use hydraulic grips to pull steel cables a few inches at a time - in this case to raise the *Costa Concordia*.
3. The dirty waterline marks the slow progress of the parbuckling.
4. The salvage team observes the parbuckling operations carefully from the remote control room.

Not part of the original plan, the "blister sisters" were two additional steel tanks that TITAN/Micoperi installed on the *Costa Concordia's* suspended bow to provide support during and after the parbuckling, as well as during the refloating phase. The tanks, which were fixed to the hull by means of three anchor pipes installed in the bow-thruster tunnels, collectively weighed 1,500 tons and each measured 23 meters long and 20 meters high. Much like a cervical collar/neck brace used on patients with spinal injuries,

they provided a net buoyancy of 5,000 tons to the front of the ship, reducing the chance of further damage.

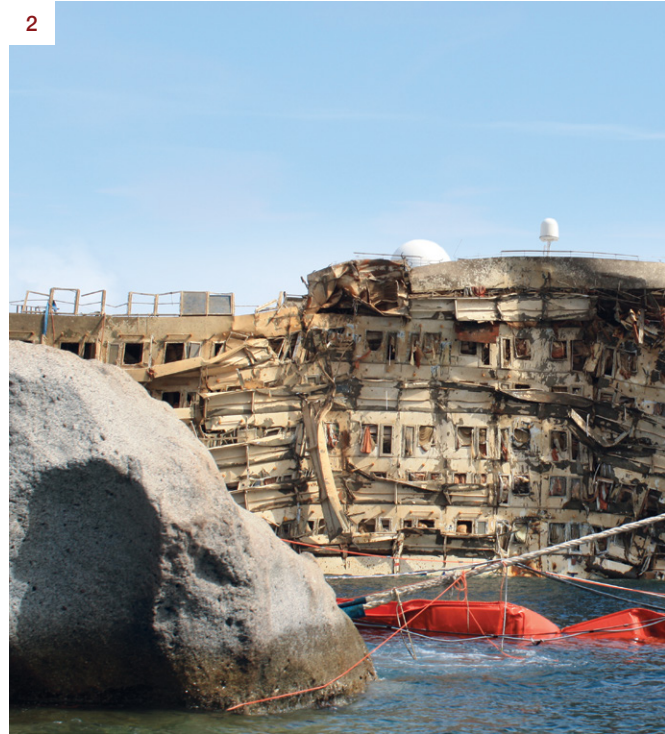
1. A TITAN salvor monitors parbuckling operations on scene.
2. A view of the damaged starboard side of the *Costa Concordia*
3. Reporters lined the shore to film and broadcast the parbuckling live. From this vantage point, they had an incredible view of the submerged side as it slowly rose from the water.

Upon her righting, the true damage to the vessel could finally be seen. Huge crater-like indentions where she came to rest on her side were now brazenly on display. Crushed steel, broken windows, shifted furniture and strewn belongings were now also visible for on-lookers.
